RE: Phase I Fault Study

Wirt Road Drainage and Pavement Sub-Project II

WBS No. M-000287-002-3

City of Houston, Harris County, Texas

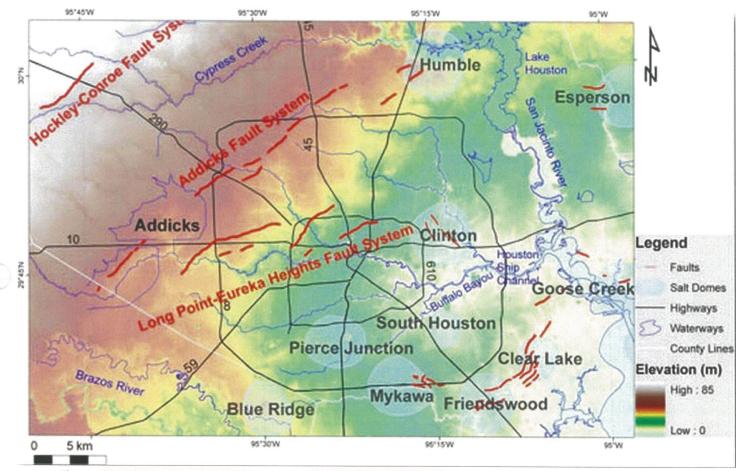
Figure 1 – Lidar Image Depicting the Long Point Fault System and Other Fault Systems in the Houston Area (Khan and Engelkemeir, 2008)

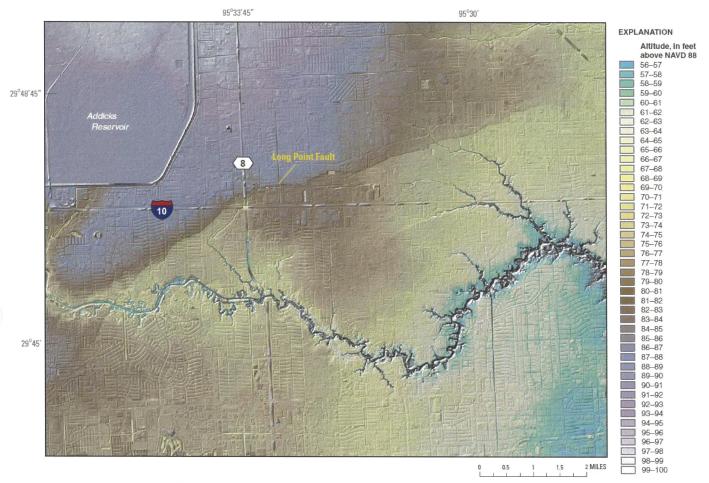
The U. S. Geological Survey (USGS), in conjunction with the Harris-Galveston Coastal Subsidence District, used a Lidar-derived digital elevation model (DEM) to enhance the precision of fault locations in the Houston area (Shah and Lanning-Rush, 2005). Figure 2 depicts the location of the Long Point Fault in the area between Hempstead Highway and IH 10, based on Lidar DEM mapping.

Figure 2 – Location of Long Point Fault based on Lidar DEM Mapping (Shah and Lanning-Rush, 2005)

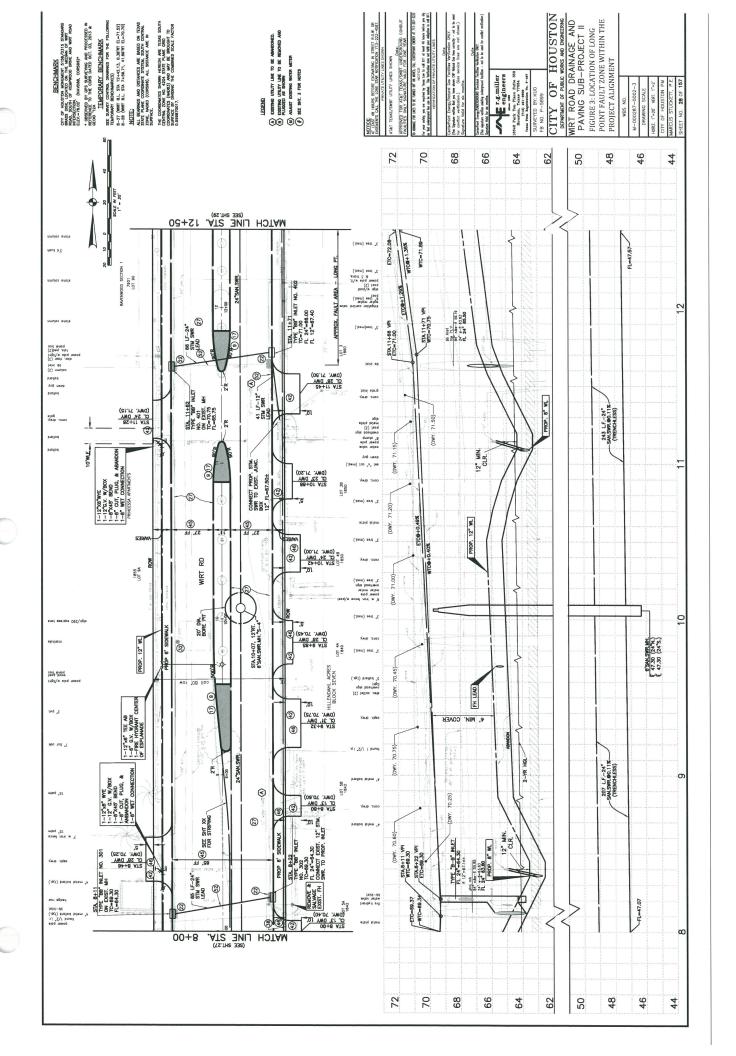
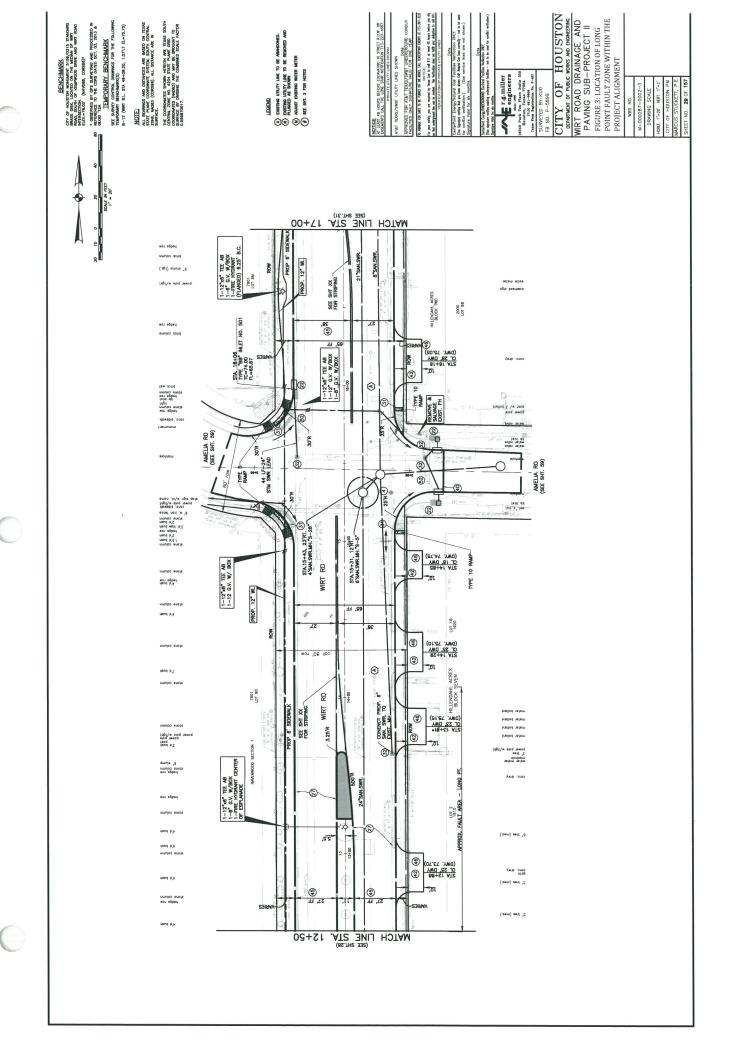
The Long Point Fault trends generally east-west through the study area. As such, its topographic expression is more readily apparent on north-south trending streets in the area than on east-west trending streets. Wirt Road is oriented north-south. After locating the apparent scarp of the Long Point Fault on Wirt Road, the streets running generally parallel to Wirt Road (Johanna Street to the east and Spenwick Street to the west) were examined to verify that the topographic feature located on Wirt Road between east-west trending Amelia Road and Long Point Road is the Long Point Fault. Based on correlation to surficial expressions of faulting located and observed on Johanna Street and Spenwick Street, the topographic feature observed in the 1800 block of Wirt Road, between Long Point Road and Amelia Road, was confirmed to be the Long Point Fault. Figure 3 depicts the approximate location of the deformation zone of the Long Point Fault within the project alignment on an engineering diagram prepared by R. G. Miller Engineers for the project. The deformation zone is located between Stations 11+60 and 14+10.

Location of Long Point Fault Zone within the Project Alignment

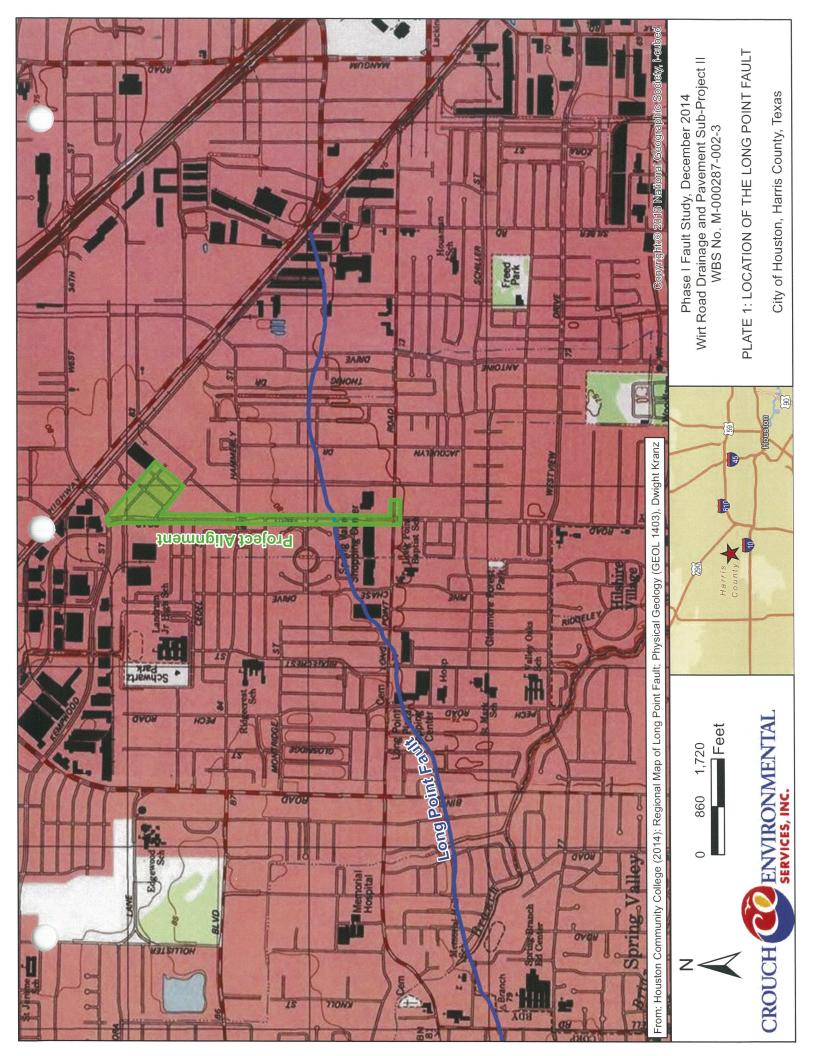
Plate 1 Location of the Long Point Fault

Plate 1 (Kranz, 2014) depicts the location of the Long Point Fault in the area of Houston, Texas between Hempstead Highway and Interstate Highway 10 (IH 10). Plate 2 (Verbeek and Clanton, 1981) depicts the location of the Long Point Fault relative to other fault systems mapped in the greater Houston area.

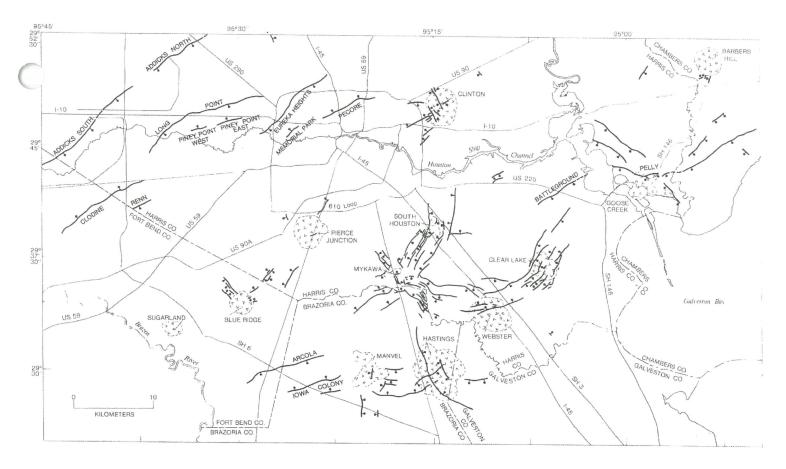
PLATE 2

Note in the attached Plate 2 that the Piney Point West and Piney Point East Faults appear to be complementary relief faults to the Long Point (growth) Fault, as depicted conceptually in Plate 3.

Plate 2 Regional Faulting in the Area of Houston, Texas

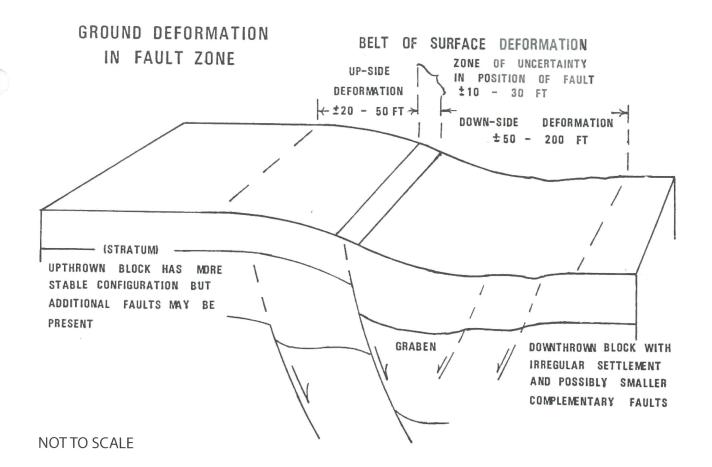
PLATE 3

No geologic structure maps of the Long Point Fault were obtained as a result of the Task 1 Literature Review. The attached Plate 3 from Van Siclen (1981) presents a generalized geologic block diagram showing typical surface and subsurface features associated with a growth fault system such as the Long Point Fault System.

Surface and Subsurface Geologic Diagram Depicting Typical Features Associated with Growth Faults
